# Manhole Inspection Summary

Manhole # S33E\_\_026MH

Insp Date: **8/4/08 11:12 AM**

**Location** Address: **229 w clay st**

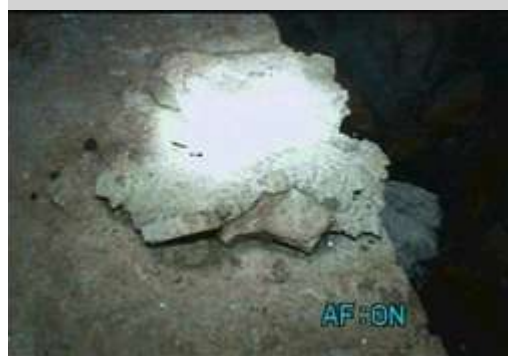
misc

channel debris

bench debris

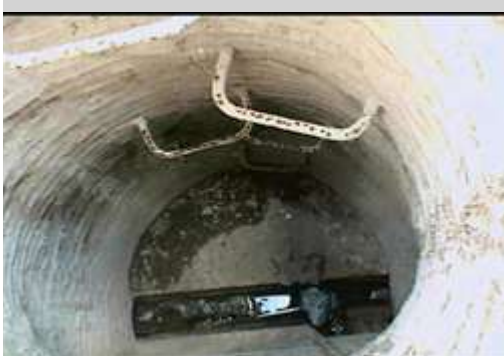
Defect 3

Count: **6** Missing: **0** ☒ **Corroded**

steps

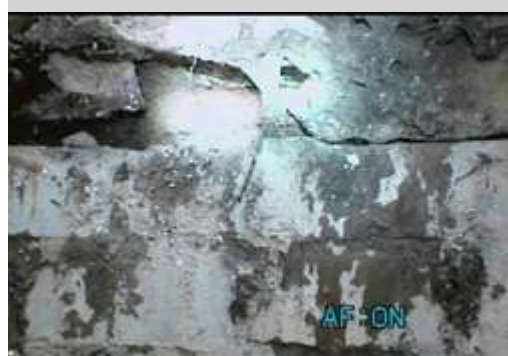
Defect 2

Condition: ☐ Sound ☐ Cracked ☐ Root Intrusion ☒ **Loose Brick** ☒ **Deteriorated**

missing brick in corbel

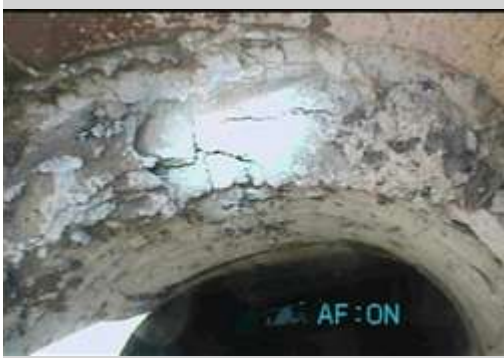
Defect 1

Offset: **4** (in.)

offset

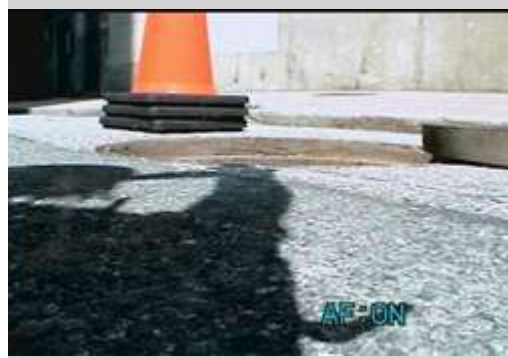
Defect 3

☒ **Cracked**

frame cracked

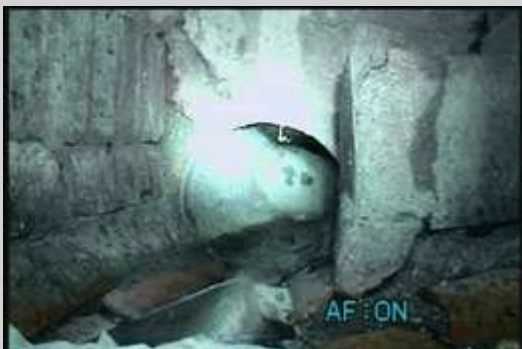
6 O'Clock Inflow

Comments **Pipe at 6 is sealed**

sealed off
